UTILIZING THE "ADVANCE AND RELIEVE" METHOD TO REDUCE HORIZONTAL STRESS AFFECTS ON THE MINE ROOF, A CASE STUDY

National Institute for Occupational Safety and Health
Pittsburgh, PA

Tanoma Mining Co.
Marion Center, PA

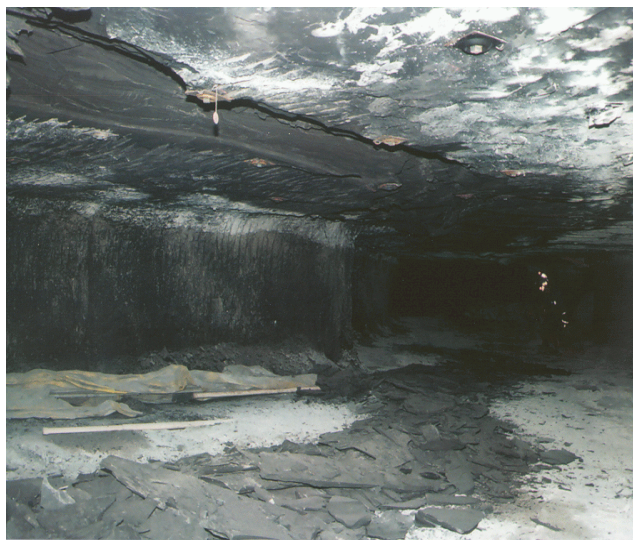
Figure 4. Stress induced cutter roof failure

Although much of the stress damage occurred after the roof was supported outby the faces, occasionally, damage occurred during face advance or prior to installation of the primary support. However, the commencement of the roof falls varied from a few days to several weeks after an opening was mined. About 50 pct of the roof falls in the N 30° W direction occurred in the belt entry whose width is usually wider than the other entries.

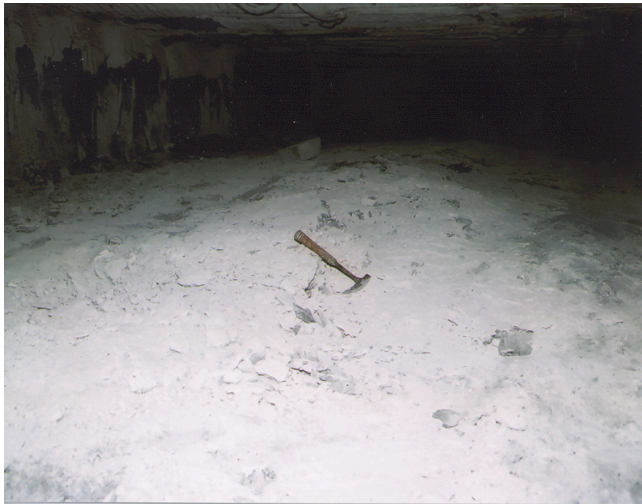
Figure 12. Floor heave experienced in E15 panel.

With the start of "advance and relieve" pillaring in both panels E15 and E17, significant floor heave developed. Over the panels the floor consisted of 1 to 2 ft of shale underlain by 4 to 5 ft of fireclay while the overburden averaged 700 ft. Figure 12 shows typical floor heave that occurred. Systematic roof to floor convergence measurements were made in the intersections of the belt, L1 and L2 entries along the length of each panel.

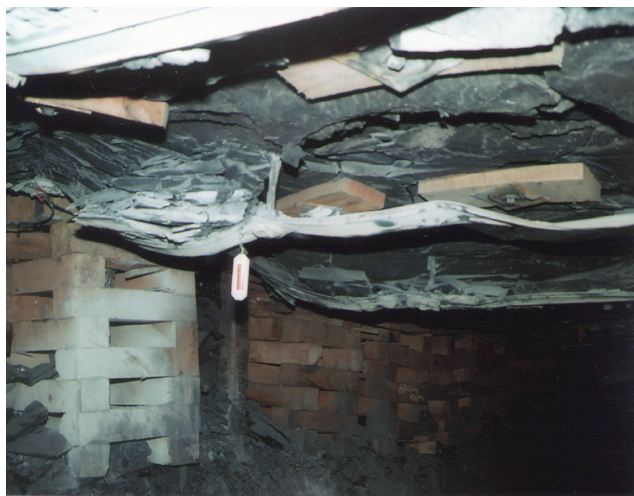
Figure 16. Rear abutment stress damage in the L1 entry

Roof damage in the entries and crosscuts in the panels just outby the cave was probably caused by the rear horizontal stress abutment. This abutment did not advance with the mining, but essentially remained stationary. In E15, the damage consisted of cutters developed in the R1 entry from the cave outby for a distance of approximately 200 ft. This stress damage was parallel to the length of the cave.

Stress damage also occurred in the crosscut just outby the cave. A cutter ran across the belt entry then into the crosscut from the belt entry to the L1 and L2 entries. This was a narrow zone about 10 to 15 ft wide of fairly severe roof damage that crossed the entire panel at a right angle (figure 16). This damage zone ran both in the N 30° E and east-west crosscuts with an orientation sub parallel to the direction of the maximum horizontal stress.
